# **MARLBOROUGH SOUNDS HARBOUR NAVIGATIONAL RISK ASSESSMENT**

Prepared For : Marlborough District Council  
Report Number : 05NR109  
Issue : Issue 1  
: April 2005

## MARLBOROUGH SOUNDS HARBOUR NAVIGATIONAL RISK ASSESSMENT

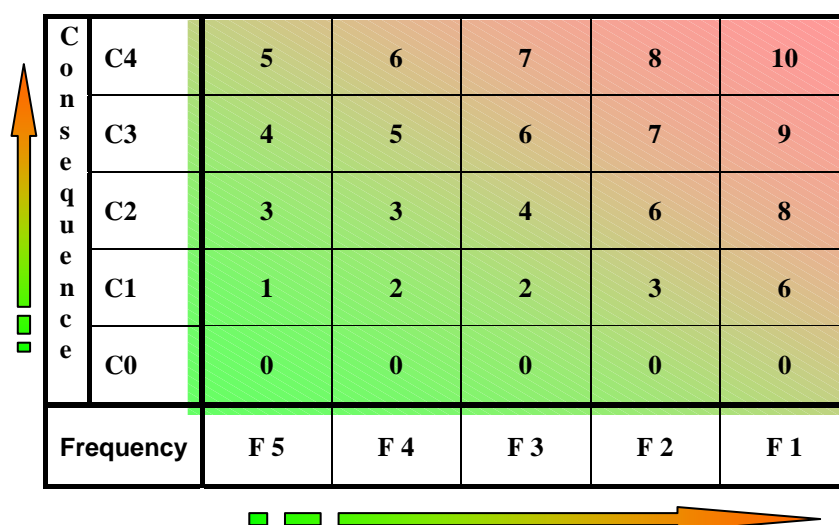
**Table 1 - Risk Matrix**

Using the risk matrix (**Table 1**, below) taken from **Annex A**, each hazard was scored against a scale of 1 to 10 for each of the four consequence categories within the NZ Risk Assessment Guidelines (i.e. impacts on: Life; Property; Environment; Harbour Stakeholders).

C o n s e q u e n c e	C4	5	6	7	8	10
	C3	4	5	6	7	9
	C2	3	3	4	6	8
	C1	1	2	2	3	6
	C0	0	0	0	0	0
	Frequency	F 5	F 4	F 3	F 2	F 1

From the frequency and consequence data (see **Annex A**), risk scores were obtained for each hazard using these criteria, in both the 'most likely' and 'worst credible' scenarios (i.e. providing eight risk scores per hazard). Each hazard was scored optimistically, to provide the risk assessment with a cautious approach when the average situation is taken into account.

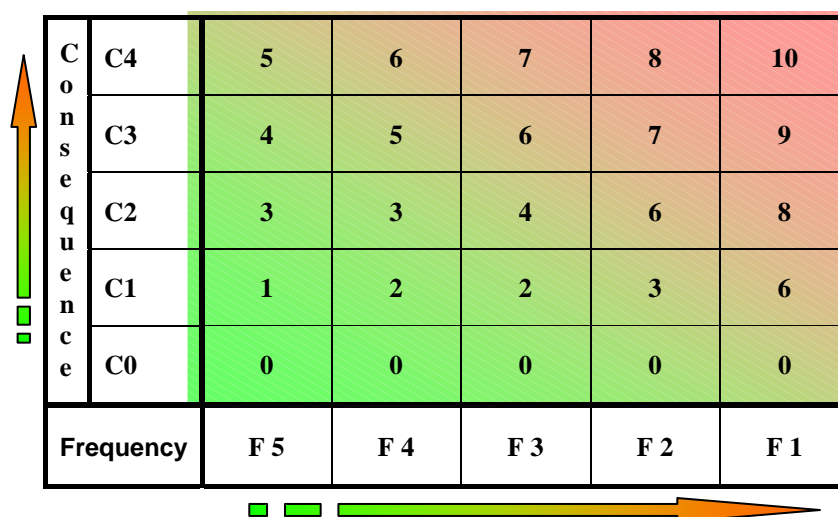
### Risk Matrix Used to Score This Risk Assessment

C o n s e q u e n c e	C4	5	6	7	8	10
	C3	4	5	6	7	9
	C2	3	3	4	6	8
	C1	1	2	2	3	6
	C0	0	0	0	0	0
Frequency		F 5	F 4	F 3	F 2	F 1
